# Difficult mining conditions in 153 Orebody at a depth of 4550 ft at Vale Inco's Coleman Mine

Z. Hosseini, R. Lewis  
*Vale Inco Limited, Sudbury, Canada*

**ABSTRACT:** Vale Inco's Coleman Mine 153 Orebody is a narrow vein deposit with a dip that varies from 30 to 70 degrees. It has a strike length of 1200-feet and the current mining extends from the 4250 level to 5100 level. The primary mining method is mechanized cut-and-fill although drift-and-fill is also used in wider sections of the ore zone. The ore body is divided into six main mining horizons with an average of three mining blocks on each cut.

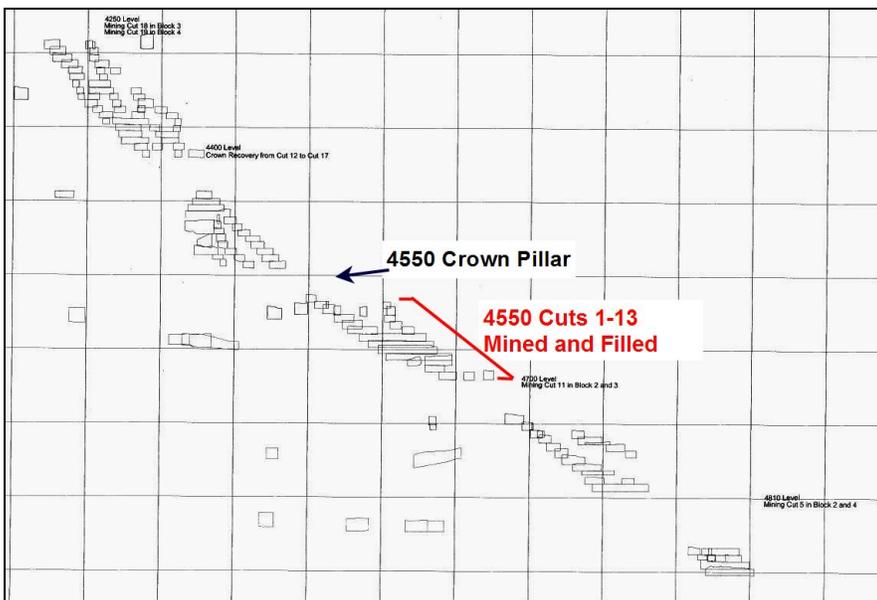
With six mining horizons in the 153 Orebody, each cut-and-fill level successively mines upward, in individual cuts (each 9-ft high), creating a diminishing crown pillar, Figure 2. Cut-and-fill mining may eventually be converted to bulk recovery for the crown pillars where more challenging mining conditions are expected. To some extent, more difficult mining conditions are being encountered in the footwall of 4550 level at cut 13.

Figure 2. A typical section of 153 orebody, showing the crown of 4550 level

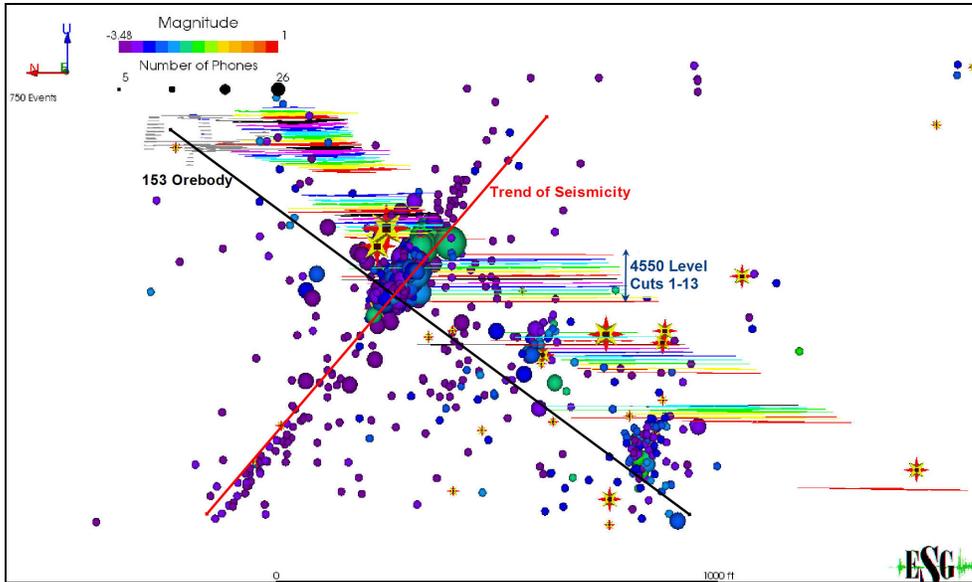
During the early stages of mining cut 13, an unrelenting seismicity trend was identified in a north-south direction, Figure 4. This trend is in the opposite direction of the principal stress as shown in Table 1.

An assessment of the seismicity data showed that this trend has been consistent and repeatedly encountered in and around the same areas of the ore zone with the past mining activity. In addition, a study of the locations of rock bursts showed that a group of previous rock bursts also

Figure 4. 153 orebody levels, looking east, showing the trend of seismicity

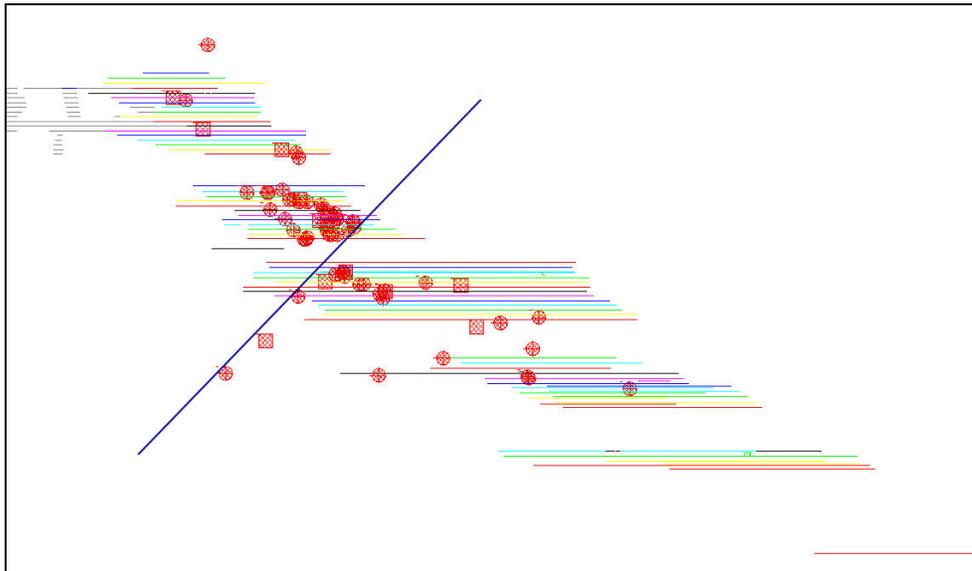
plots in close proximity to this trend. Many of these rock bursts occurred in the first cuts of the 4400 level, above the 4550 level, Figure 5.

Figure 5. The location of rock bursts over the mining history; these are plotting near the seismicity trend.

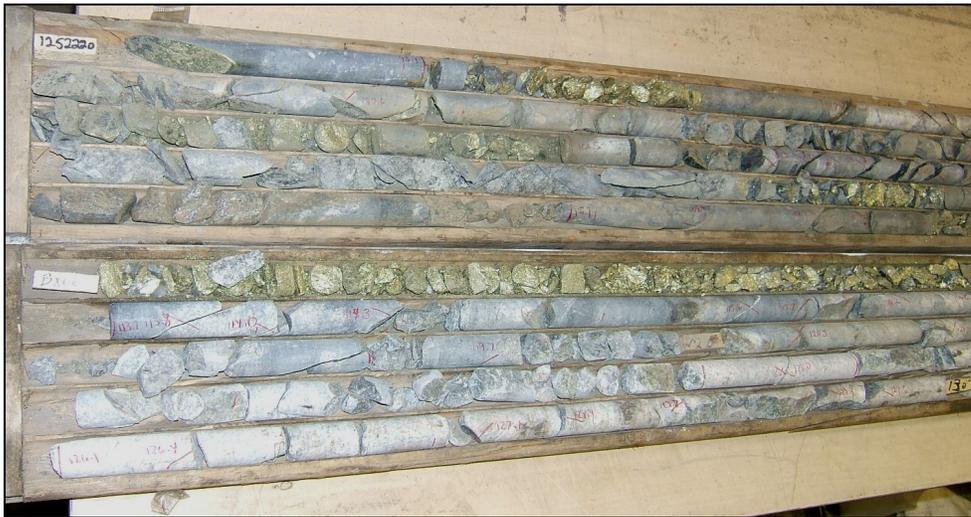
The flat holes, 1252220 and 1252230, were found to be situated in significantly fractured ground. This was expected due to the seismic activity and bursting that had been encountered in this area during the mining of cuts 12 and early cut 13. Figure 7 shows a portion of 1252220 hole.

Figure 7. Core from hole # 1252220.

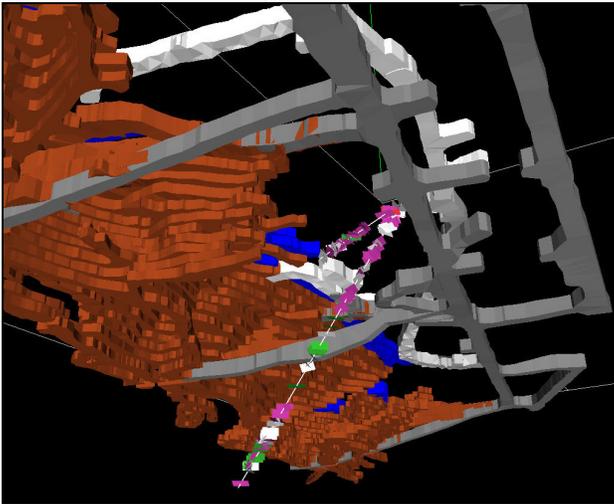
Two of the diamond drill holes, 1252210 and 1252240, were drilled with a dip of 40 degrees for the added purpose of assessing the condition of the footwall rocks using the Acoustic TeleViewer probe. This was done in addition to the geotechnical core logging conducted for these boreholes. Figure 8 shows the 3D representation of the ground conditions in the two holes based on the results of the Acoustic TeleViewer. There are no major fault/shear structures causing ground problems, however, in hole 1252240, at a depth of 57-ft, a joint set with a dip of 55 degrees and dip-direction of 290 degrees is noticeable. This data aligns with the results of coring and also fits with the observed trend of seismicity.

Figure 8. Visual results from Acoustic TeleViewer probing. Note: Foliation planes (green), jointing (purple), break-outs (white) shown in true dip and dip direction.

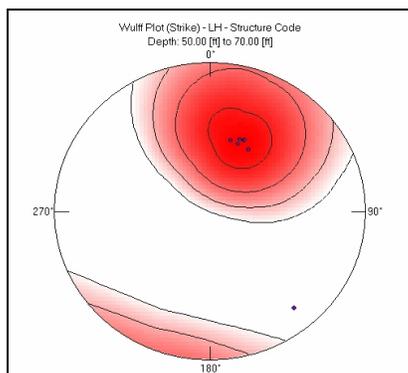
Table 5 summarizes joints properties from hole 1252240 which is also represented in a stereonet in Figure 9, indicating the pole of joints between the depths of 55-65 ft.

Figure 9. Stereonet showing the joints between depths of 55-65 ft for the 1252240 hole

The shear zone was identified at a depth of 57-ft in the core and at a depth of 55-ft using the Acoustic TeleViewer data. Note that there is a minor difference in depth to the shear zone and this is due to the measuring techniques used. The core logging measures depth starting from the hole collar itself while the TeleViewer starts measuring depth from a cable instrument that is located outside the hole and not at the collar.
