# Difficult mining conditions in 153 Orebody at a depth of 4550 ft at Vale Inco's Coleman Mine

Z. Hosseini, R. Lewis  
*Vale Inco Limited, Sudbury, Canada*

**ABSTRACT:** Vale Inco's Coleman Mine 153 Orebody is a narrow vein deposit with a dip that varies from 30 to 70 degrees. It has a strike length of 1200-feet and the current mining extends from the 4250 level to 5100 level. The primary mining method is mechanized cut-and-fill although drift-and-fill is also used in wider sections of the ore zone. The ore body is divided into six main mining horizons with an average of three mining blocks on each cut.

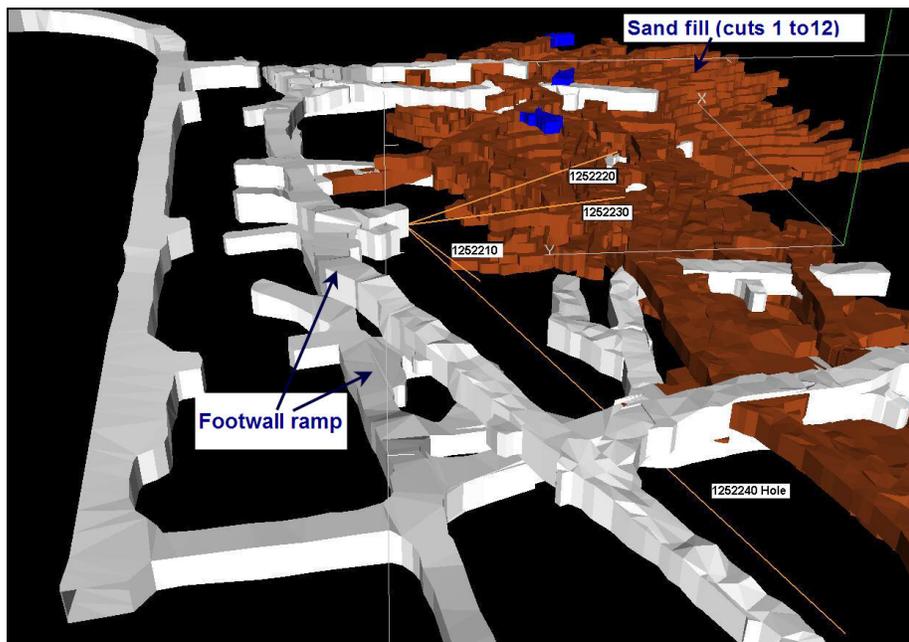
Figure 6. Location of 4 diamond drill holes, drilled from the ramp toward the orebody

Holes 1252220 and 1252230 were drilled flat and were aimed at the zone of high seismicity that was identified during the early stages of mining cut 13. The other two holes, 1252210 and 1252240, were drilled at dips of 40 degrees into the footwall of 4550 level. The holes were logged and the ground conditions were further assessed using the Acoustic TeleViewer.

The flat holes, 1252220 and 1252230, were found to be situated in significantly fractured ground. This was expected due to the seismic activity and bursting that had been encountered in this area during the mining of cuts 12 and early cut 13. Figure 7 shows a portion of 1252220 hole.

The logging of the inclined holes, 1252210 and 1252240, showed that the footwall rocks are in good condition with no major structures present. However, a zone of jointed ground was noticed in hole 1252240 at a depth of 57-ft and this feature was further defined as a shear zone. This zone is aligned with the direction of the seismicity trend as shown previously in Figure 4.
